DEPARTMENT OF TRANSPORTATION

Federal Aviation Administration

Airworthiness Directives; Various Aircraft Equipped with Wing Lift Struts

2015-08-04 **Various Aircraft**: Amendment 39-18140; Docket No. FAA-2014-1083; Directorate Identifier 2014-CE-036-AD.

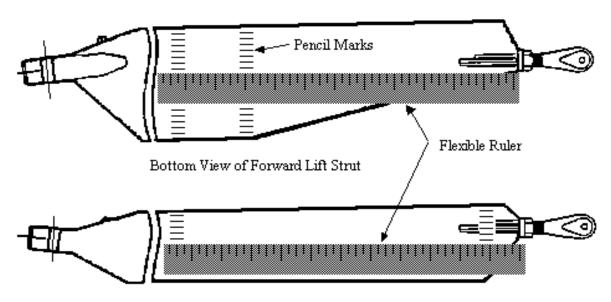
Figure 1

Bottom View of Rear Lift Strut
